Eastham Public Library

View from Rear of Building

Eastham Public Library
190 Samoset Road
Eastham, MA
January 11, 2017

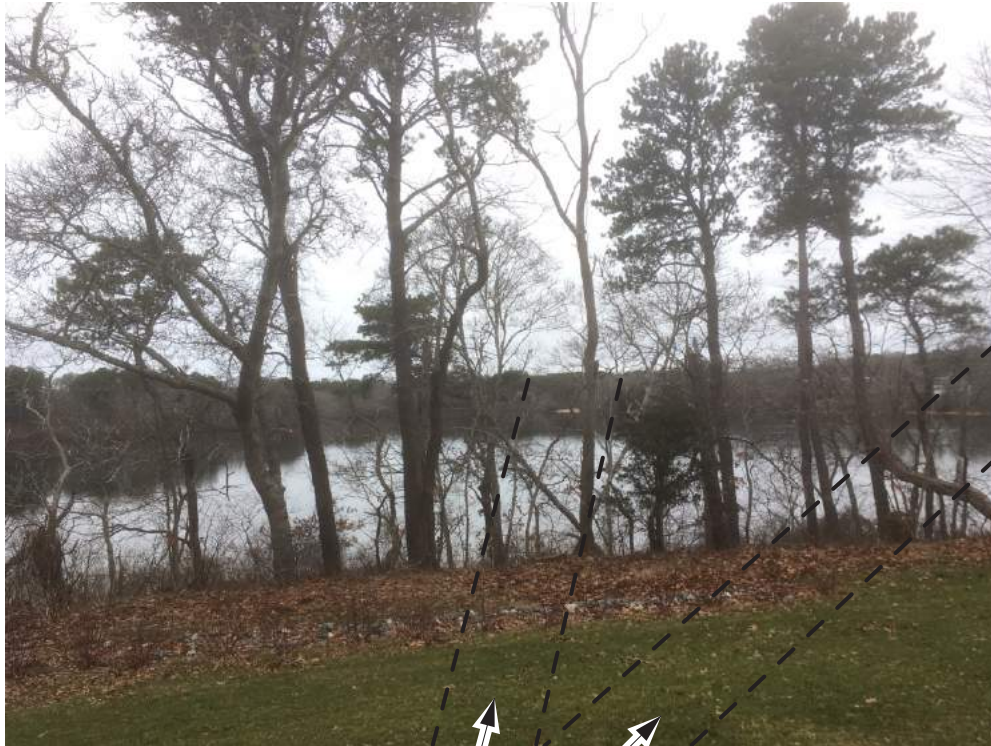
View Perspective from the
left rear of the building

Approximate
view corridor

Remove undesirable Black Locusts,
Norway Maples, and stump growth
Lateral prune selected trees.
Refer to the landscape plan.

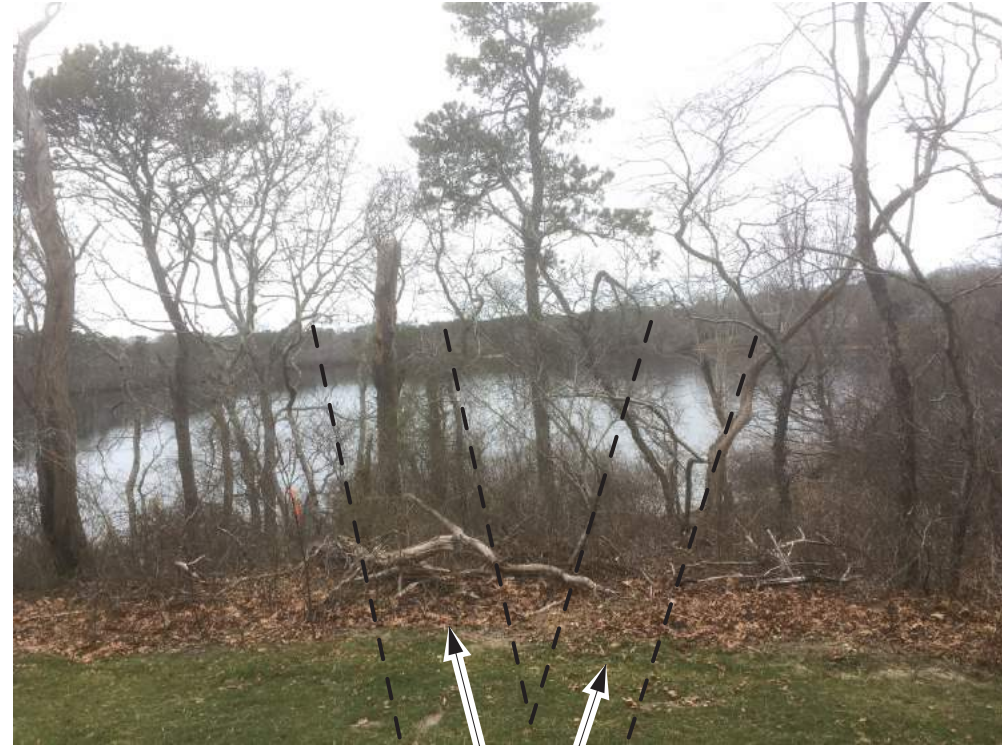
View Perspective from the
right rear of the building

Approximate
view corridor
